DEVELOPMENT OF GEOTECHNICAL GROUND MODELS FOR SLOPE INSTABILITY, EASTERN SIDE, TAKAKA HILL, TASMAN DISTRICT

A thesis

Master of Science in Engineering Geology

University of Canterbury

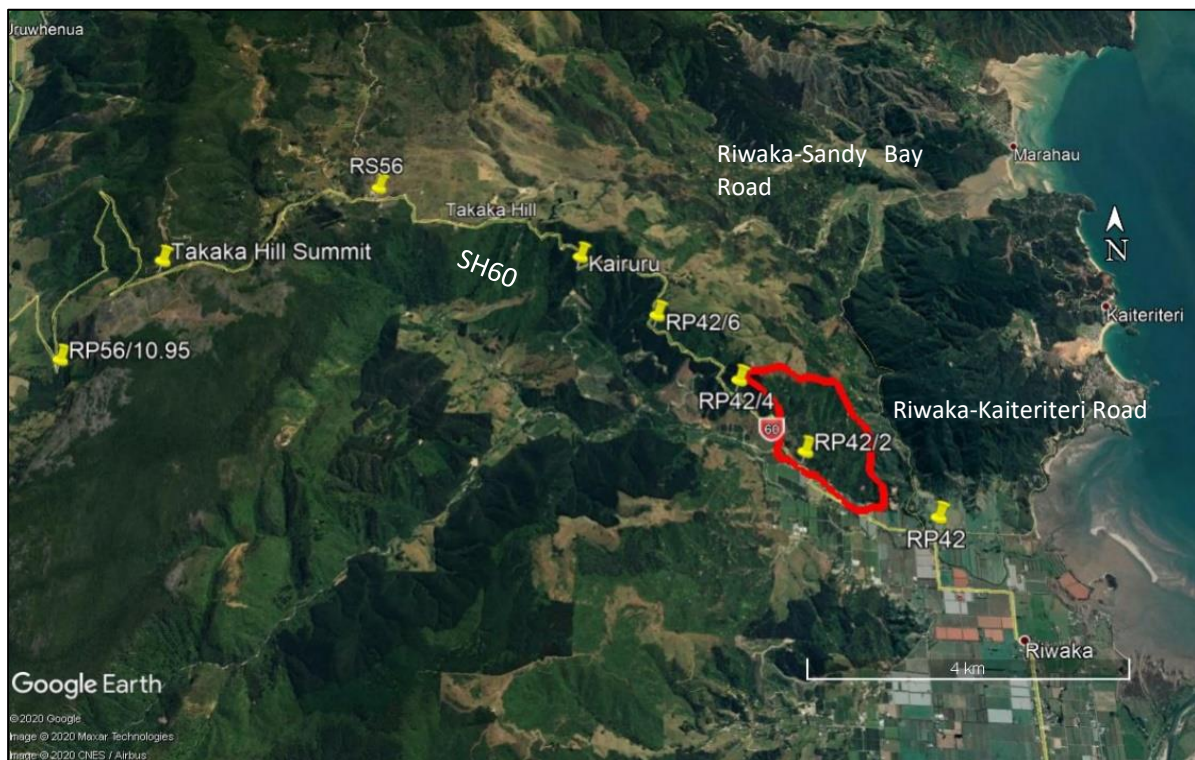
Figure 2.1: Location of State Highway (SH) 60. The RP numbers in the Figure are referred to in the text. SH60 starts at the T junction at RP42, and the subsequent numbers are in kilometres from RP42 (e.g. RP42/2 is 2 km from RP42). The red box is the detailed catchment area being studied. SH60 continues after RS56 56/10.95 towards Takaka. Source: Google Earth (2019).

SH60 starts at the T-intersection where the traffic can either turn westward towards Takaka Hill and continues along the SH60 corridor or turn eastwards towards Kaiteriteri (Figure 2.1). Shortly before its intersection with the Riwaka Valley Road at RP42/2.00, SH60 begins to climb and, for the next 14km, it traverses the south eastern side of Takaka Hill to its summit at RP56/4.02 (Opus International Consultants Limited, 2001).

The report on Takaka Hill Management by Opus International Consultants Limited (2001) states that the present road follows a practical route, and that any significant deviation from this route would be geometrically unacceptable for significant portions of the road length. The detailed catchment area in this study is located approximately between RP42/2 and RP42/4.5 (Figure 2.1).

on 25th February and fully opened to one lane traffic on 7th April (NIWA, n.d.). Two types of mass movement were again observed in the study area: shallow translational soil slides and channelised debris flows. The failures occurred between RP42/2.2 and RP42/5.6 (Figure 2.1).

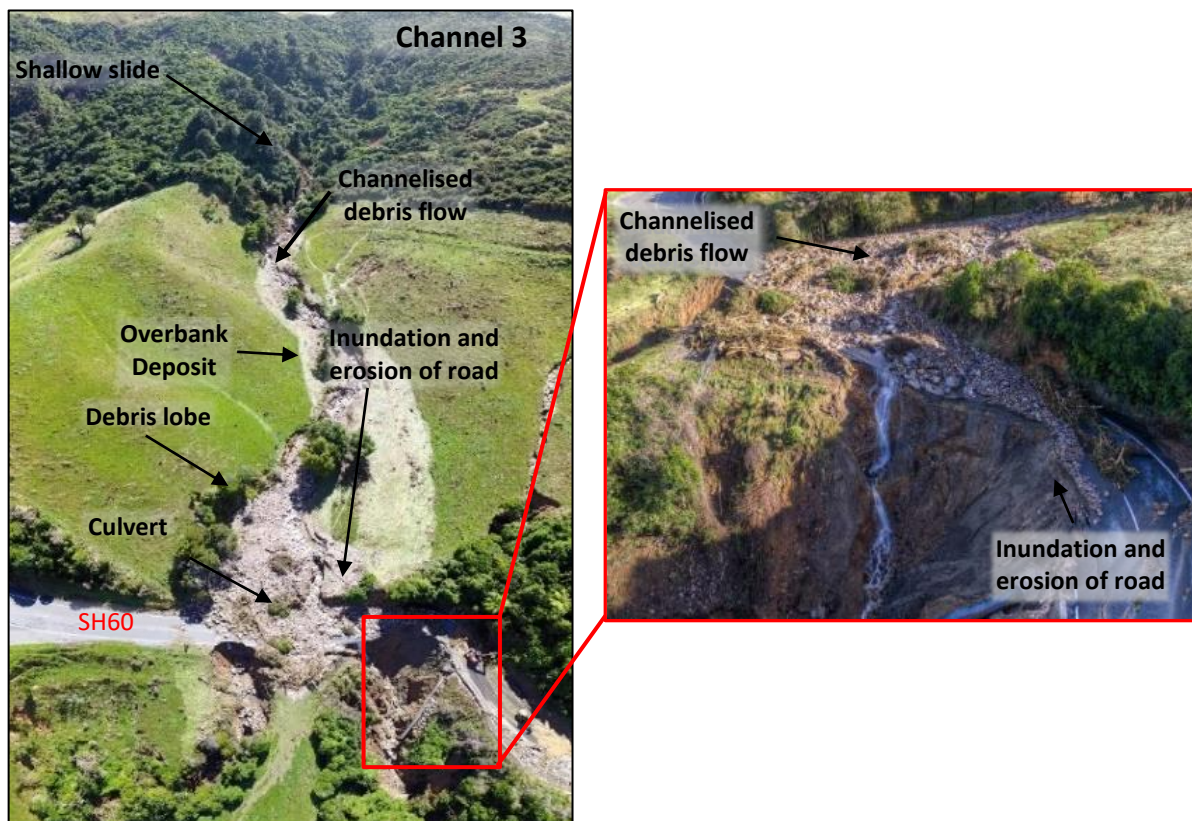
Figure 2.9: (A) Deposits and erosion from a channelised debris flow triggered by Ex-tropical cyclone Gita in February 2018. Photo provided by GEOadvise Limited (B) Enlarged image showing erosion and inundation from debris flows causing undermining the road embankment. Source: (Stuff.co.nz, 2018).

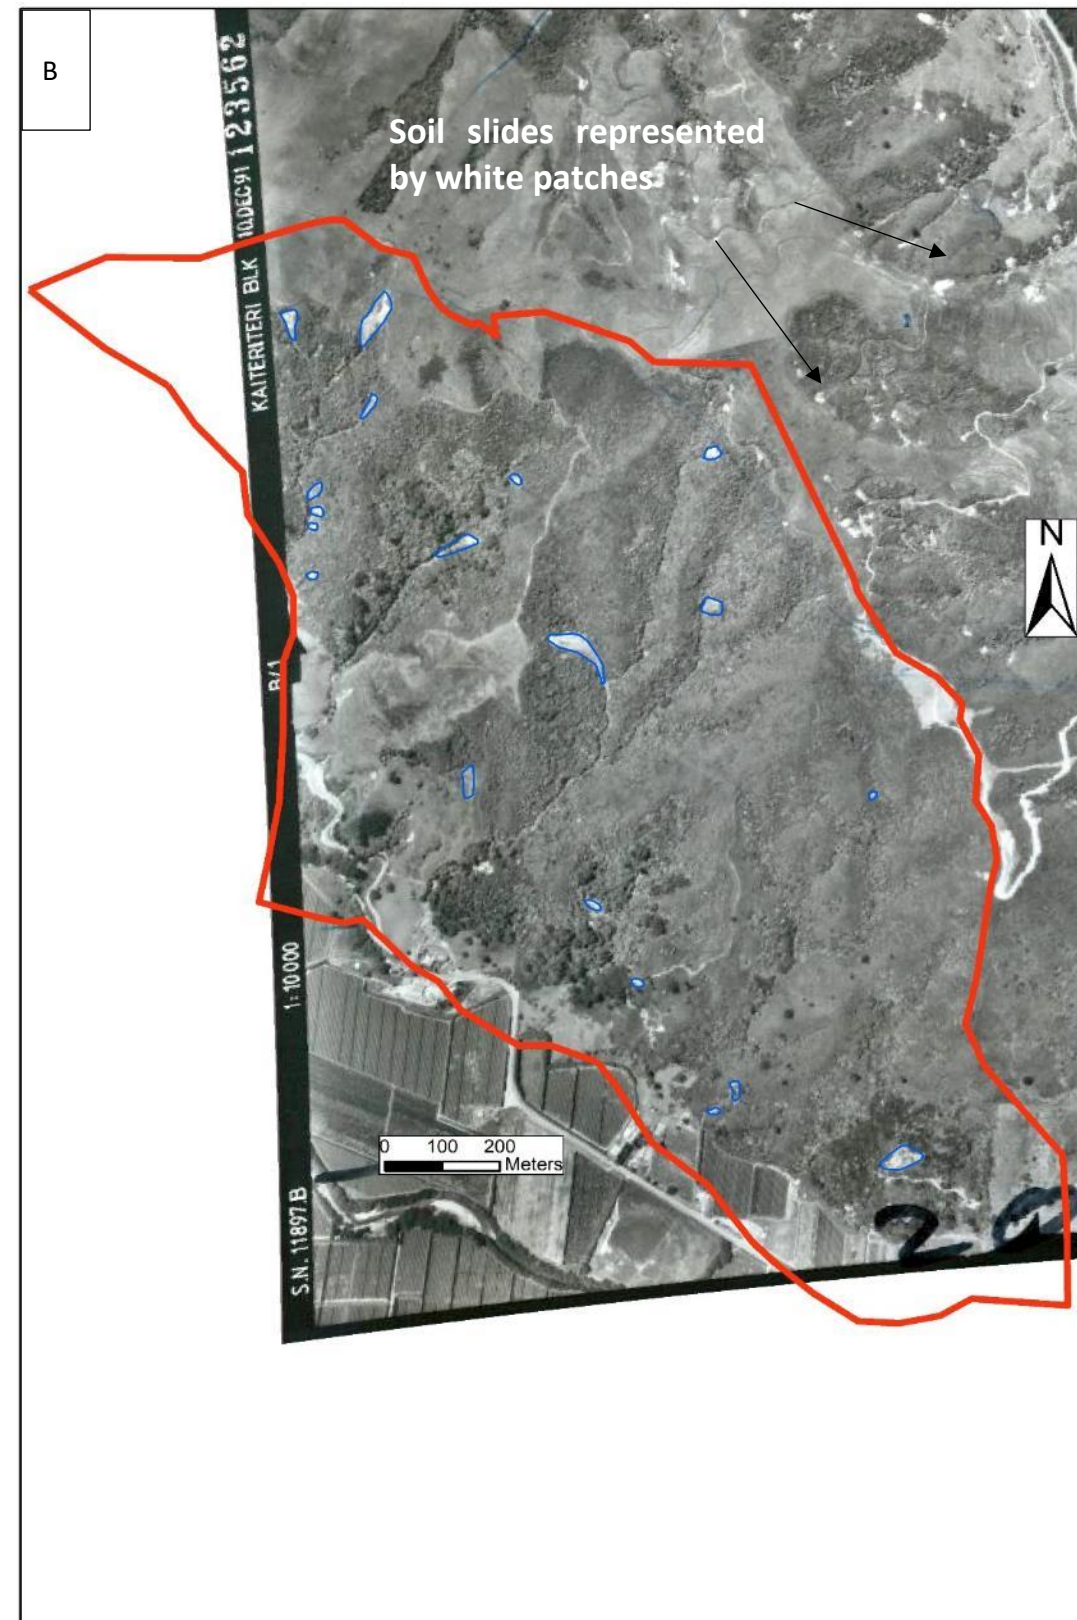
Figure 2.12: Historical images identifying geomorphological changes before and after the 1990 storm event. (A) 1989 aerial image. The green polygon represents soil slides. Aerial Imagery provided by the Tasman District Council (B) December 1991 aerial image; this is the only coverage of the area in 1991. The blue polygons represent slides generated in 1990. Aerial Imagery supplied by Aerial Surveys Limited.

The 1989 aerial image (Figure 2.12 A) shows the slopes covered with vegetation, whereas in 1947 the vegetation was not well established. In the 41 year time period, the vegetation has become well established, representing cessation of farming. In the detailed catchment area in the 1989 aerial image, outlined by the red polygon, there is one zone of instability; however there are few soil slides (marked by green polygon) observed outside the catchment boundary.

The 1991 aerial image (Figure 2.12 B) shows soil slides marked by blue polygons. The aerial image was the only coverage available for the study area, and the only image available after the 1990 event. The failures range in size up to 120m long and 30 m wide (Figure 2.12 B). The soil slides were in vegetated slope cover and the majority of the soil slides were concentrated on areas of high relief.

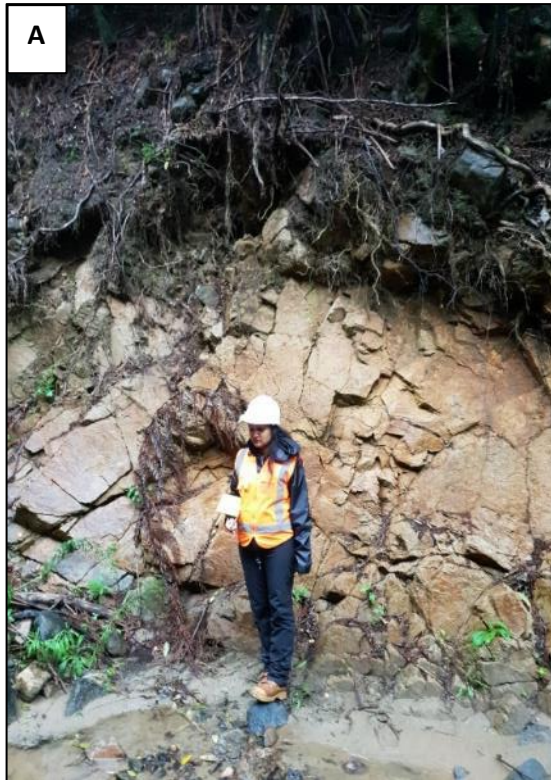
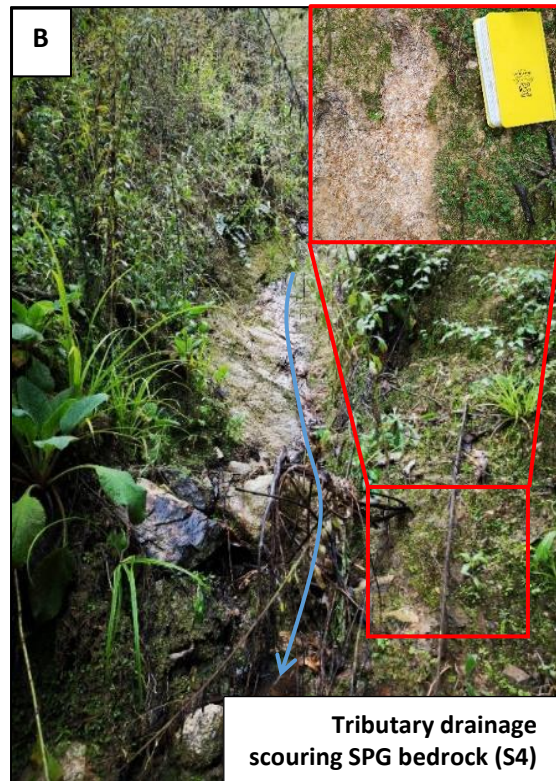
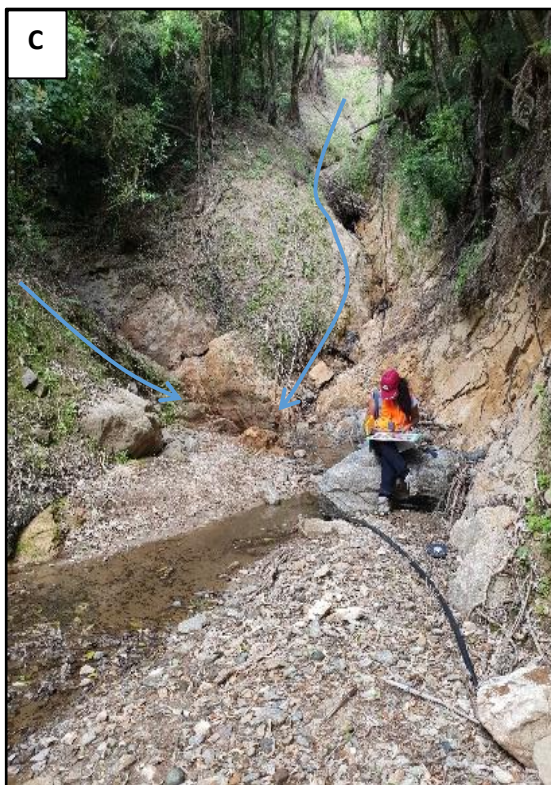
Figure 3.3: (A) Moderately weathered SPG. Iron staining and closely to moderately spaced joint sets are prominent. (B) Completely weathered SPG. The inset shows an enlarged picture of the weathered bedrock). (C) Upper end of main channel 1 where two tributary channels intersect main channel and scour into bedrock.

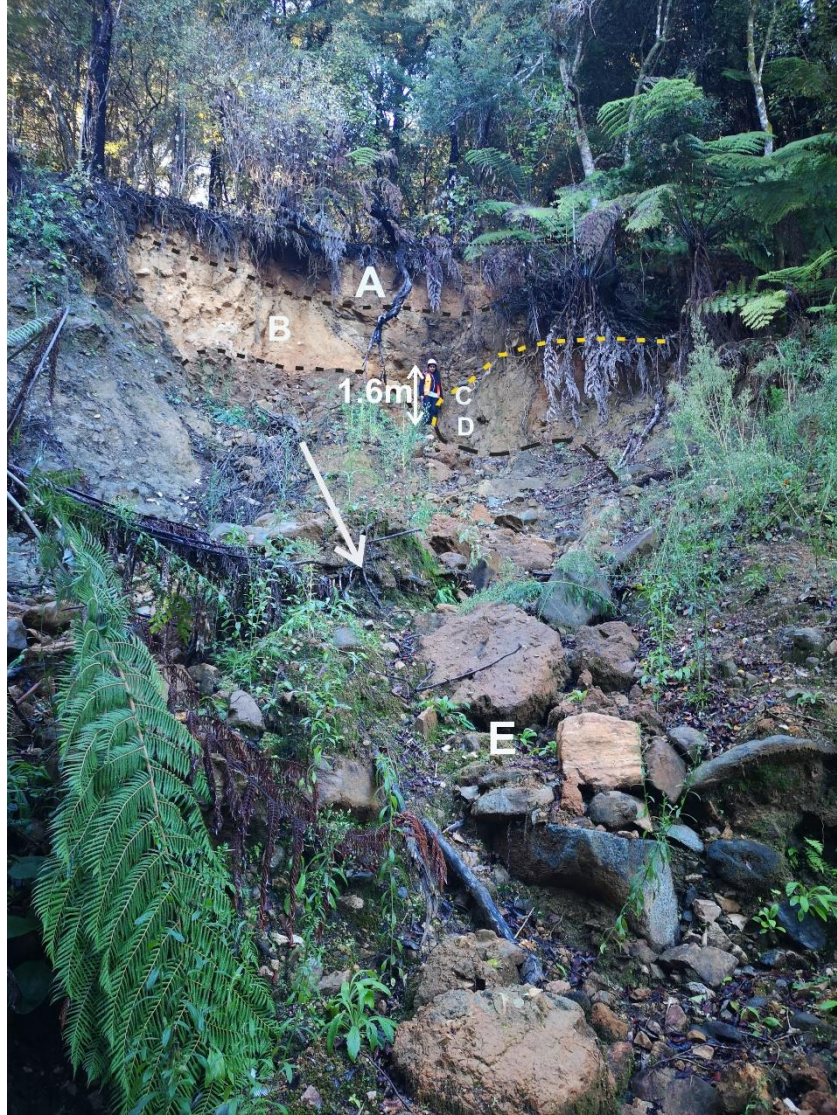
Figure 3.6: Soil slide in approximately 5 m thick colluvium (A and B) located in Channel 2 above URIC. Failure is translational on a slip plane subparallel to the ground surface at the contact with weathered URIC bedrock, marked by orange dashed line(C) is completely weathered to residual soil and (D) is highly weathered URIC bedrock. The failed material has fallen into the active drainage channel (E). Shear vane measurements were taken on weathered bedrock. The colluvium was too hard to drive the shear vane in.

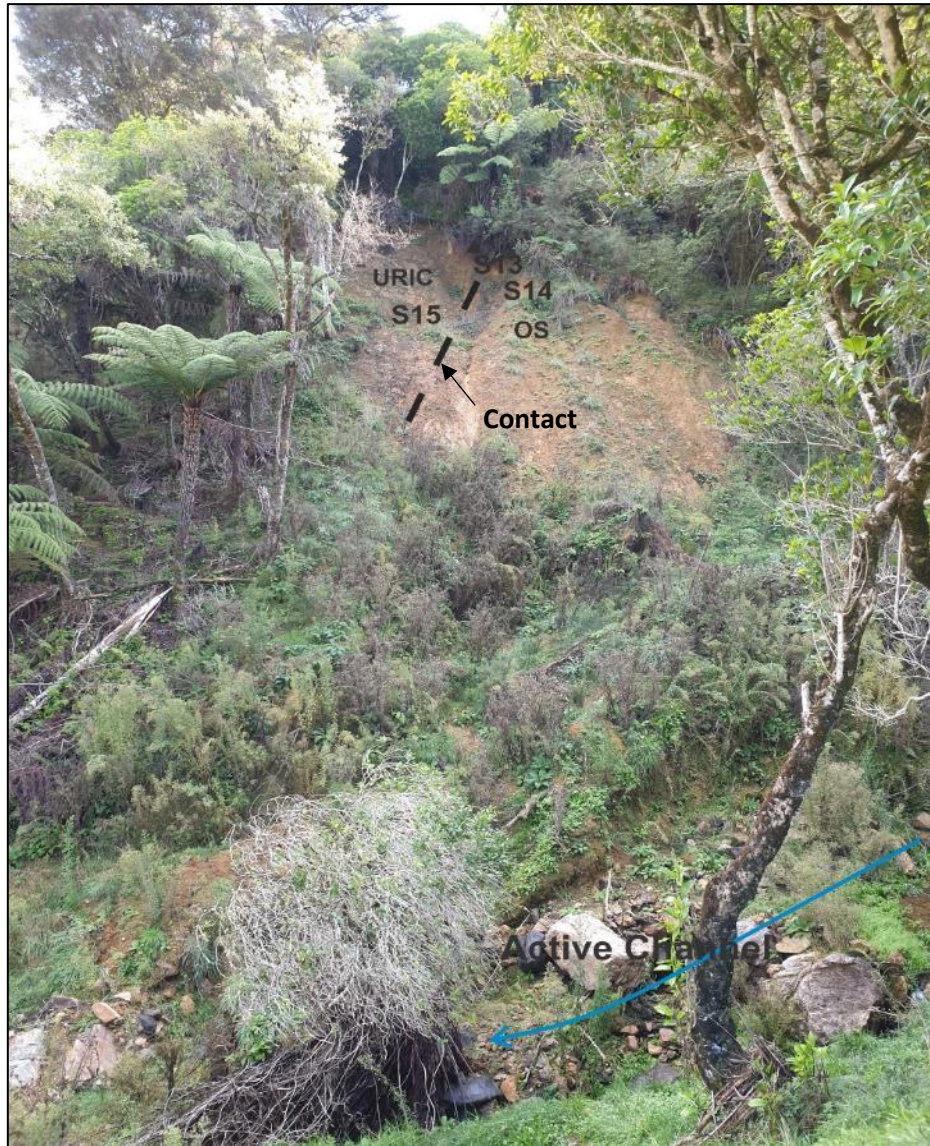
Figure 3 8: Soil slide in approximately 1m thick colluvium located in Channel 3. Failure is translational on an undulating surface. The contact between Onekaka schist (OS) and Undifferentiated Riwaka Igneous Complex (URIC) is seen. The colluvium (S13) consists of 12% cobbles. Matrix silty clay, dark brown, soft, moist, medium plasticity. The Onekaka Schist (S14): completely weathered to residual soil, orange brown, silty CLAY with some gravel, moist, high plasticity. Gravel: angular, slightly weathered quartzite. The URIC (S15): completely weathered to residual soil, dark brown with some visible black minerals, clayey SILT, moist, low plasticity. Tube and bulk samples were collected for colluvium and both weathered bedrocks.

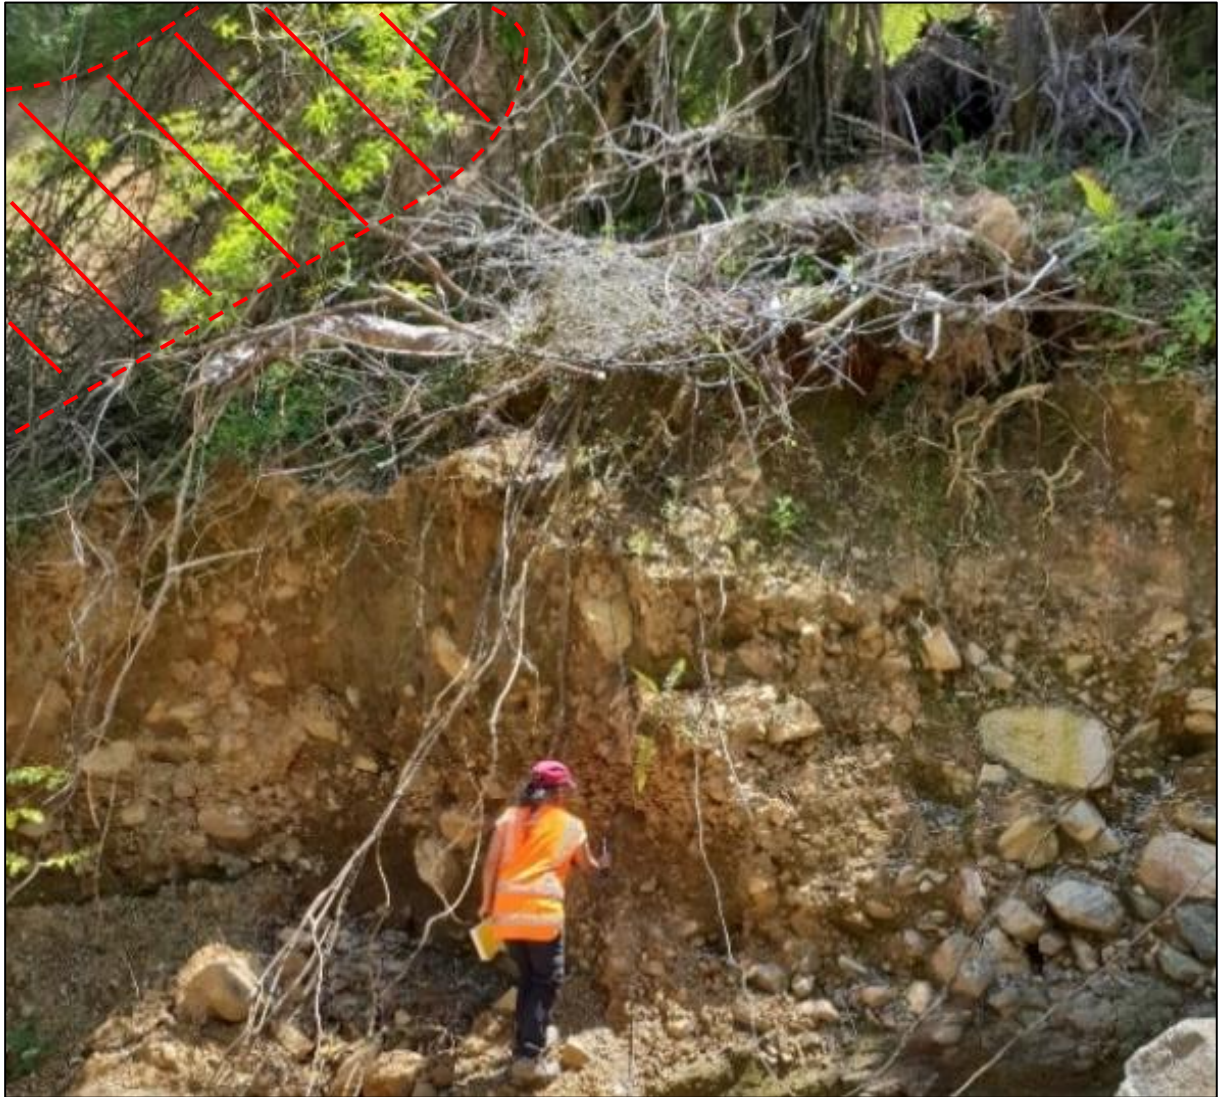
Figure 3.9: Pre-2018 debris flow deposit. The red area is the slide visible in Figure 3.8

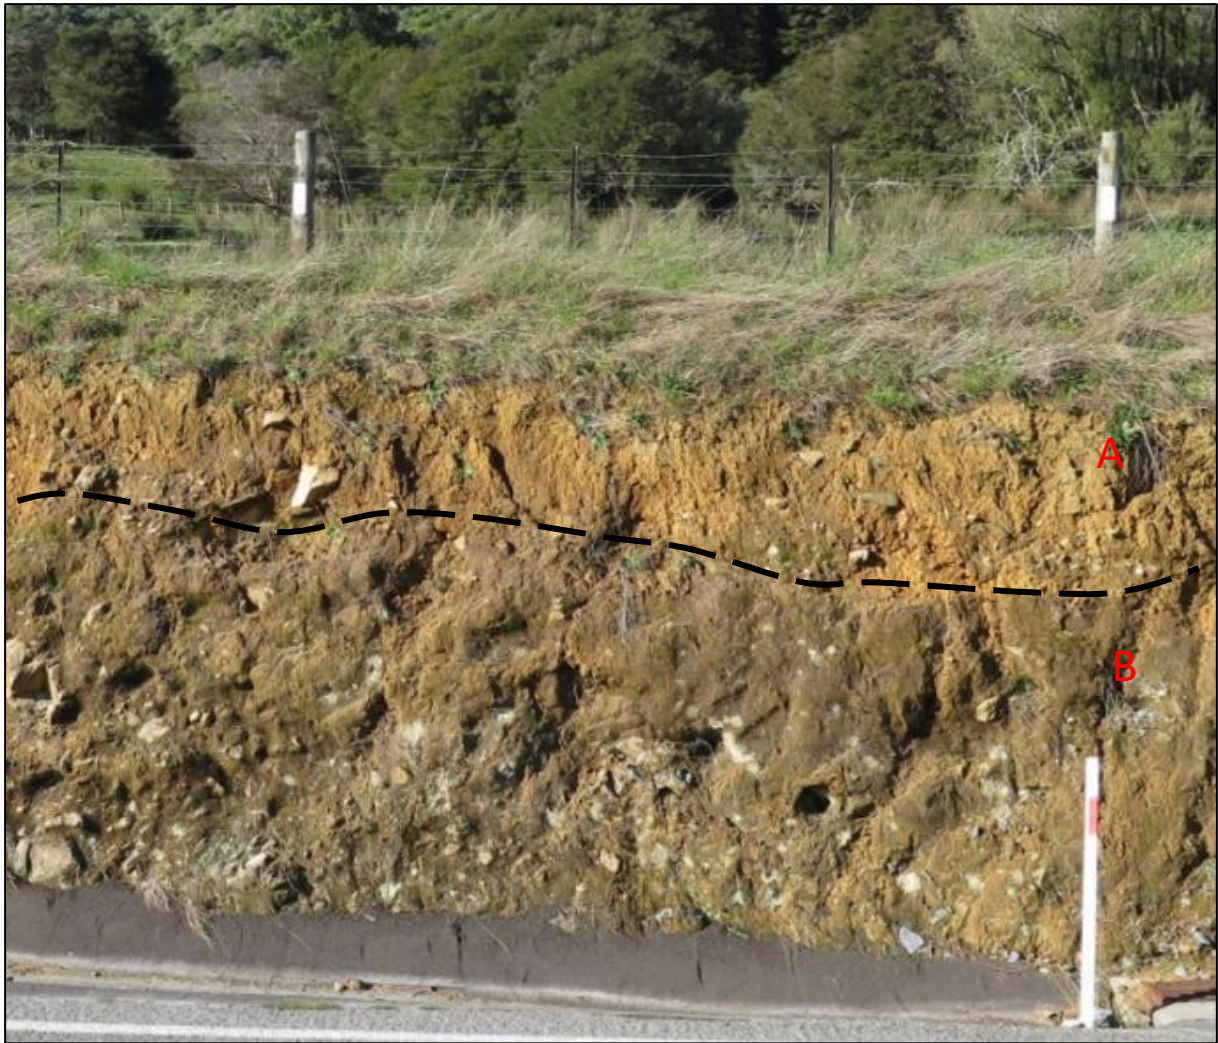
Figure 3.11: Exposure at the bottom of geophysical line 1. Approximately 3 m of debris flow deposit consisting of boulder and cobbles in a fine grained matrix. At least two units are observed: (A) Approximately 2% cobbles and boulder (B) Approximately 7% cobbles and boulders.

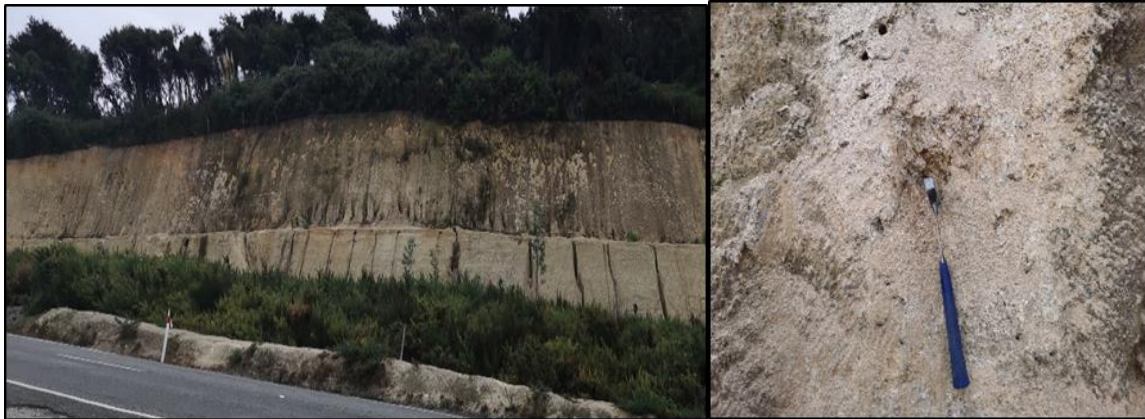
Road cut

Figure A.2.1: Riwaka –Kaiteriteri Road. Highly weathered, white with iron staining, porphyritic, SPG. Silty SAND, with some gravel and trace clay, moist, no plasticity, well graded. Gravel: sub angular to angular quartz and feldspar. Sample 1 –highly weathered SPG collected both as tube and bulk sample.

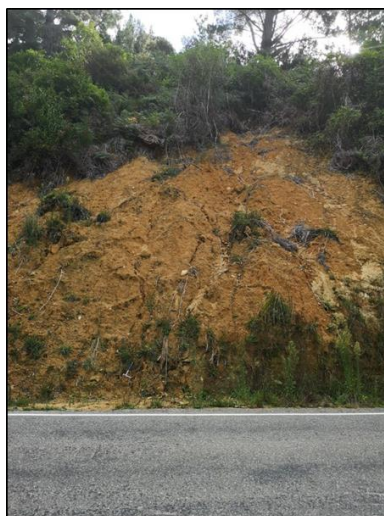
Figure A.2.2: Riwaka –Sandy Bay road. Shallow Soil slide. Failure in colluvial soil derived from SPG. The soil is described as silty clay with some gravel, orange brown, firm, moist, low plasticity. Gravel: angular to sub-angular, unweathered to moderately weathered granite gravel. Sample number 2. Both tube and bulk sample were collected.

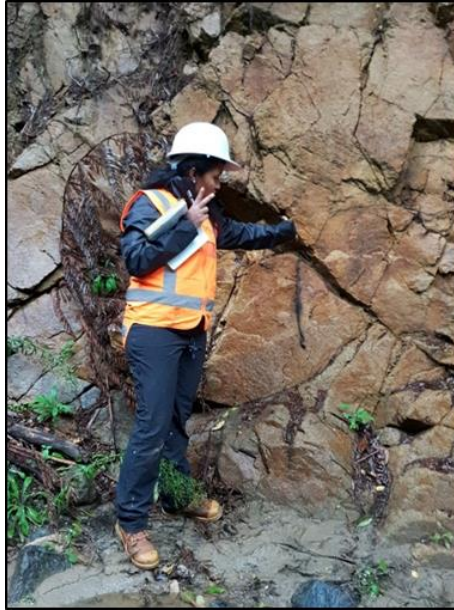
Figure A.2.3: SPG outcrop at the end of channel 1. Moderately weathered, white with iron staining, jointed, SPG, moderately strong to weak, moderately to closely spaced joint set, clay infilling along joints. Sample collected for point load test and thin section. Schmidt hammer test was also conducted.

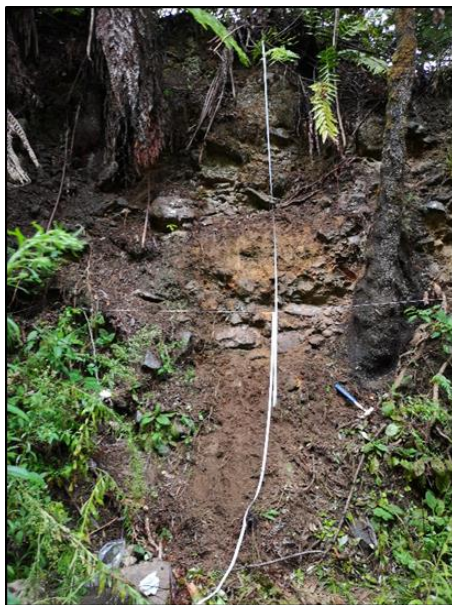
Figure A .2.6: Log 1-Pre-2018 debris flow deposit. 1 is without interpretation and 2 is with interpretation. (A) matrix supported (B) clast supported deposit, clast is angular to sub angular, random orientation (C) matrix supported –sandy silty, brown, moist, low plasticity and poorly graded. Bulk Sample collected (S3). (D) Clast supported, sub angular to sub rounded cobbles and boulders up to 50cm.

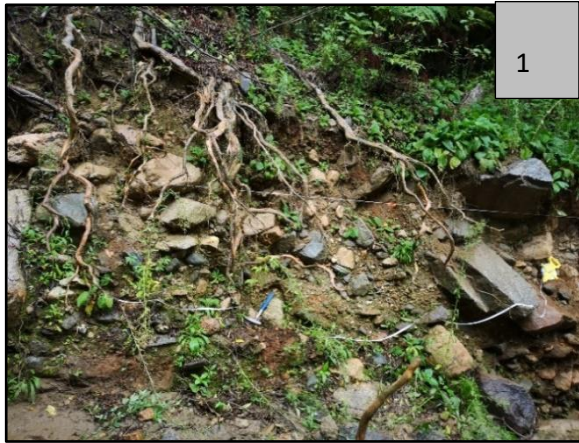
Figure A.2.7: Log 2- Pre-2018 debris flow deposit above weathered SPG. 1 is without interpretation and 2 is with interpretation. The weathered granodiorite (D) is overlain by at least 3 different debris flow activity recognized (A-C). (A) Clayey Silt with some gravel. (B) 15% clast (cobbles and boulders). Matrix: sandy with some fine gravel, dark orange brown, moist, no plasticity. Clast: up to 1m diameter, felsic and mafic igneous rock. Sub rounded to sub angular granite and diorite. (C) 20% clast (cobbles and boulders) Matrix: sandy Gravel, dark brown, moist, no plasticity. Bulk sample collected: S5 and S6.

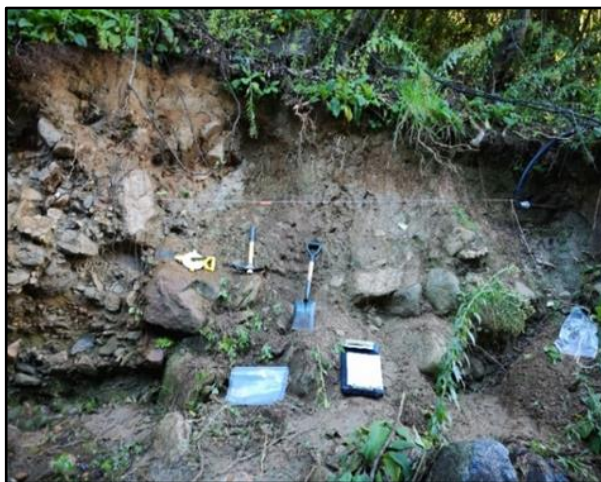
Figure A.2.8: Log 3-Pre-2018 debris flow deposit (A) 5% clast (boulders and cobbles). Matrix: clayey silt with some gravel, firm, moist, medium plasticity. Clast: sub rounded, unweathered to slightly weathered diorite and granite. Tube and bulk sample collected: S7. Shear vane measurement taken.

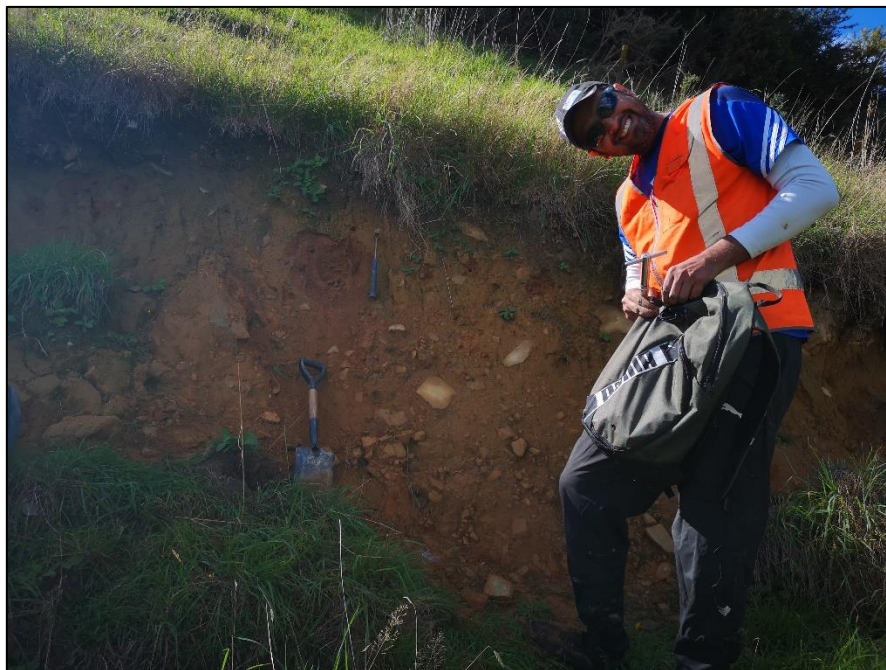
Figure A.2.14: Reactivation of colluvium material. 7% cobbles clast mostly sub angular Onekaka schist, and few URIC rocks. Matrix silty gravelly sand with trace clay, orange brown, moist, low plasticity. P.S. Ignore the happiest field assistant.

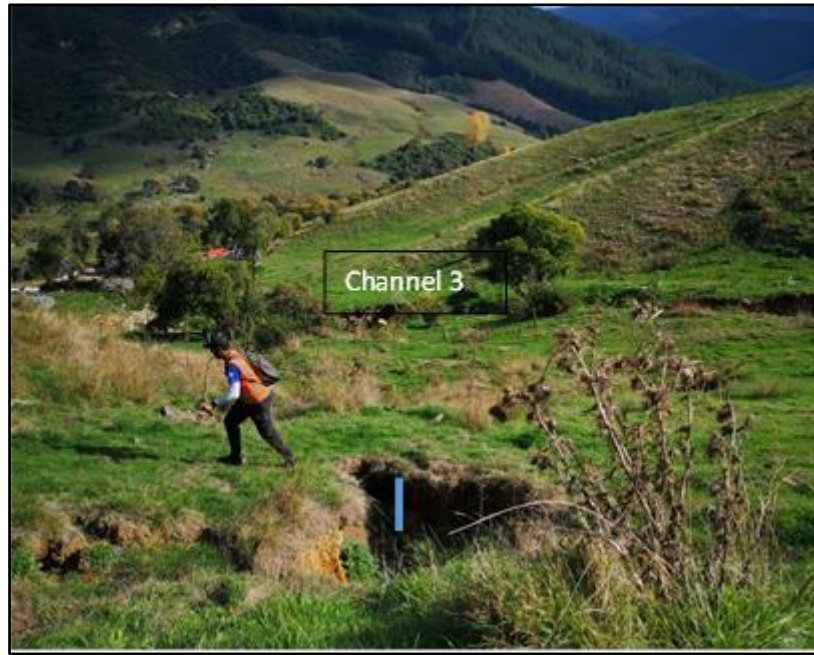
Figure A.2.15: Surface deformation- Tunnel gully up to 1 m deep, next to channel 3.

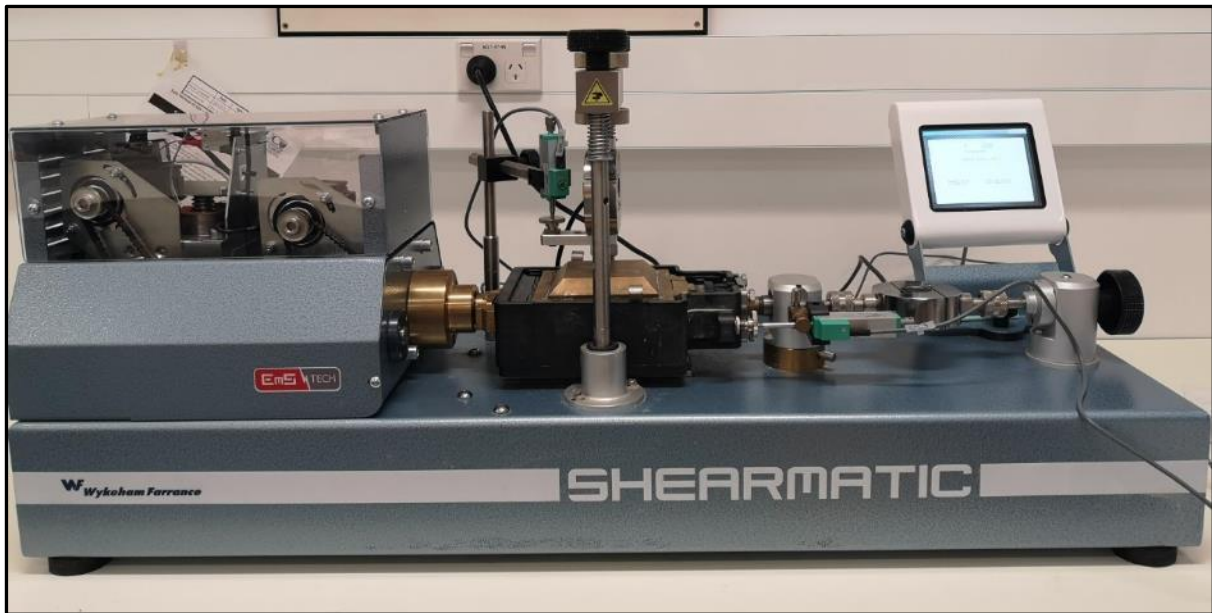
Figure B.3.1: Shearmatic machine used for direct shear testing. SHEARMATIC EmS is standalone machine by Controls Group.

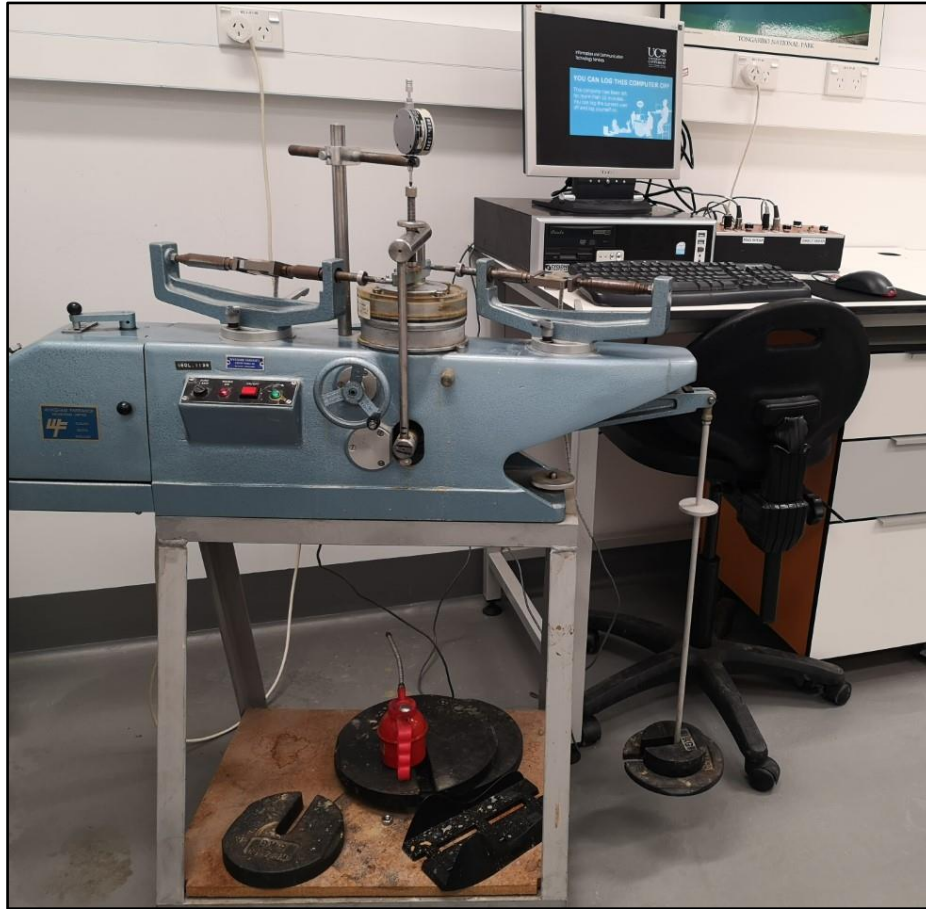
Figure B.5.1: Ring Shear setup for residual shear strength

Residual shear strength was conducted using ring shear apparatus (Figure B.4.1). This apparatus measures residual shear strength on remoulded soil (silt and clay). The angular ring shape specimen has a thickness of 5mm. The ring shear test was conducted with accordance to BS1377: Part 7 1990. The test was run under 3 different loads of 2kg, 3kg and 4kg which is equivalent to 52 kPa, 76 kPa and 100 kPa.

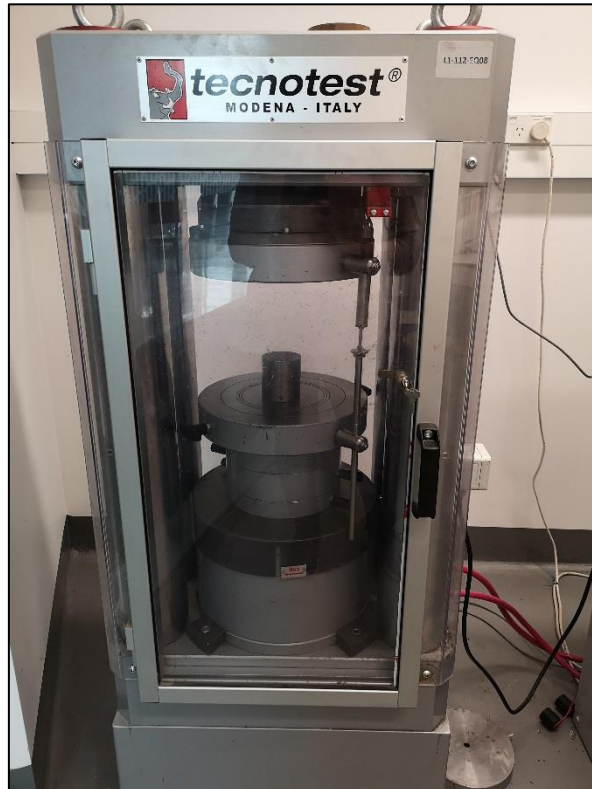
Figure C.1.1: Photograph of the UCS test apparatus

The loading frame used to conduct Uniaxial (Unconfined) compressive strength was a tecnotest, Machine series: KE300/ECE.

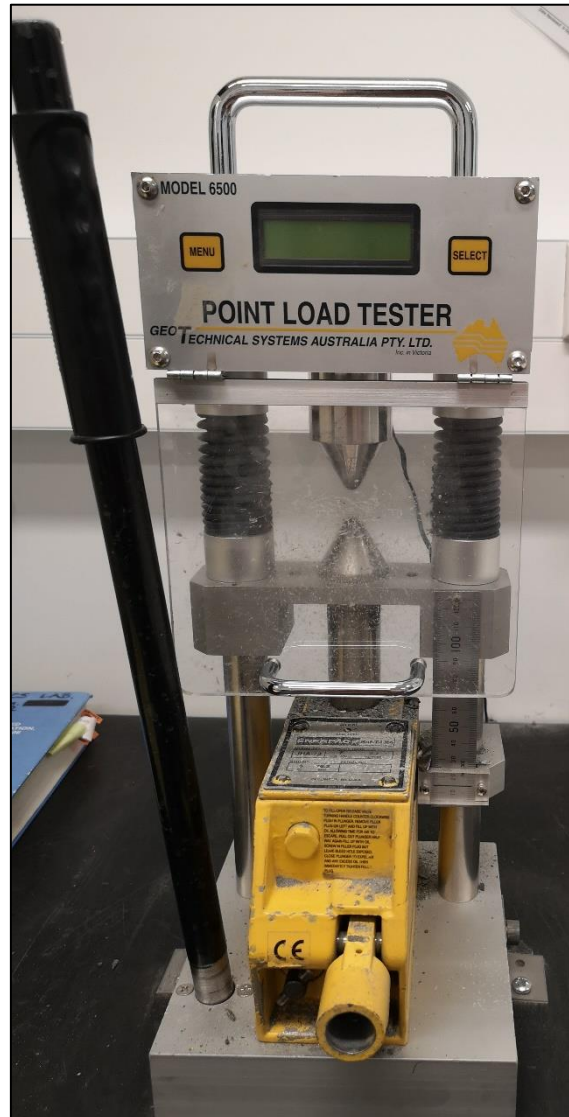
Figure C.2. 1: Photograph of Point load tester apparatus.

The loading frame used to conduct point load test was point load tester by Geotechnical Systems Australia, model 6500. It is a portable apparatus.
